# UNVEILING SECRETS

# The seismic retrofit of the Egyptian Theatre in Los Angeles serves as a model for balancing modern engineering demands with the preservation of architectural heritage.

By Jonathan Lehmer, SE and Melineh Zomorrodian, SE

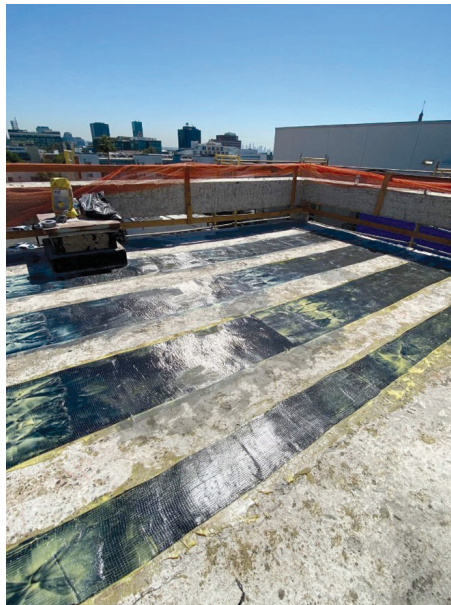
The diaphragm connections to the shear walls were then analyzed per ASCE 41 as force-controlled actions and found to be deficient. To mitigate the deficiencies, new collectors were designed to increase the shear transfer length with the addition of FRP between the diaphragm and collectors to increase the shear transfer strength (Fig. 2). The new collectors and FRP shear transfer strengthening were both designed as force-controlled actions. At limited areas, the compressive strength of the existing concrete beams was adequate for the collector compression demands but due to inadequate reinforcing quantity and development the collector tension demands required adding FRP tension collector strengthening on the existing beams. The FRP

Fig. 3. Early coordination between Structural Focus and various FRP suppliers was required to ensure the diaphragm FRP strengthening design requirements specified on the structural drawings were feasible.

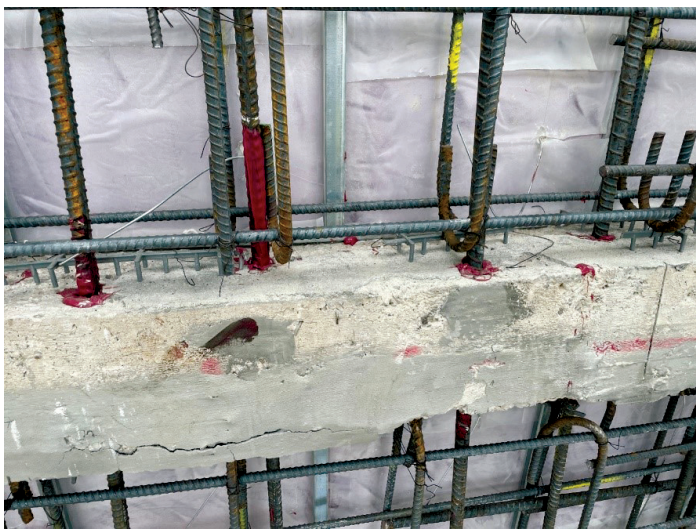
Fig. 4. During shear wall reinforcing, the installation of rebar dowels required frequent coordination despite the design considerations because the existing reinforcing proved challenging to avoid. Filling abandoned drilled holes as the drilling proceeded was important to avoid losing excessive capacity of the existing concrete members.

Continuity of the shear walls for in-plane and out-of-plane demands through the existing concrete beams and columns was achieved by doweling rebar through the existing concrete members (Fig. 4). The strength and shear friction transfer of these bars was critical for the intended shear wall behavior to act as single large wall panels per wall elevation. The design utilized large diameter bars for these dowels to reduce the number of drilled holes and the likelihood of hitting/damaging existing reinforcing bars in the existing concrete members. At shear wall special boundary zones which continued through existing beams, it was selected to demolish the length of the beams where the boundary zone occurred while keeping the existing beam reinforcing intact. This enabled the boundary zone reinforcing to be placed continuously through the beam and the portion of beam demolished was then replaced by new concrete. Temporary shoring of the existing beam was required while the ends were demolished and was accomplished with small steel pipe members that were eventually embedded in the new concrete walls.

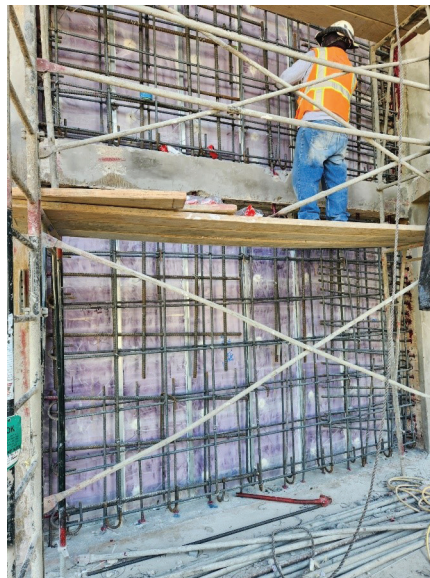
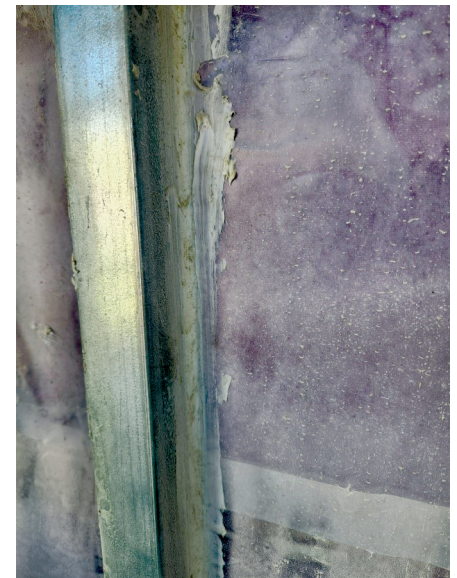
The preservation and protection of the historic plaster finishes on the interior faces of the new exterior shear walls required careful consideration during the construction of the shotcrete walls. Avoiding damage to the historic plaster was of paramount importance for the project. The contractor, in coordination with the design team, elected to use small light gauge steel shaft studs to hold the backing for the shotcrete wall along with the waterproofing membrane (Fig. 5). The shaft studs were buried inside the shotcrete wall without interrupting the continuity of the reinforcing.

Fig. 5. A shotcrete test panel with shear wall infill confirmed that proper protection of the plaster and concrete consolidation around the stud flanges was consistently achievable.

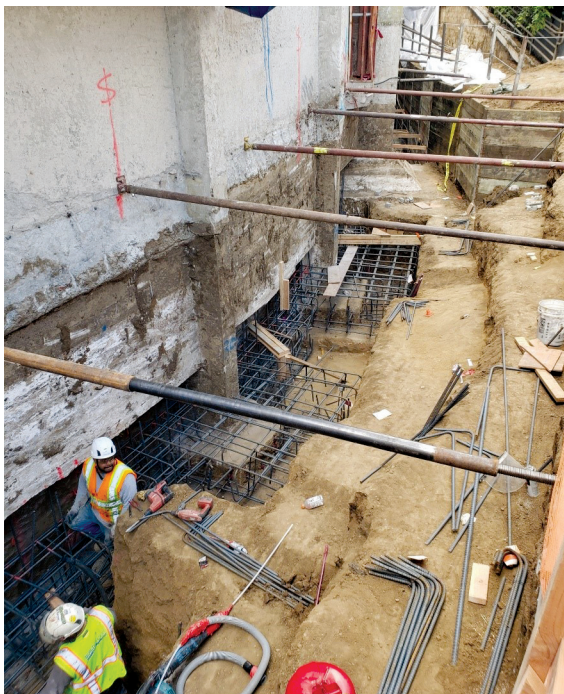
Fig. 6. Foundation construction required further coordination with the existing field conditions on a case-by-case basis; some steps that were previously assumed to be required were eliminated, and step heights were adjusted to reduce the number of steps as much as possible.

new and existing foundations were aligned in the structural drawings. This proved challenging during construction due to the required depth of excavations, adjacent property lines, adjacent building surcharges, and steps needed in the new foundations to accommodate elevation changes. Due to the project schedule, rebar shop drawings were produced based on the original drawings and fabrication began prior to excavation. Adjustments were made in the field as existing foundations were exposed and found to deviate from the original drawings, causing rebar congestion and step layout issues (Fig. 6).

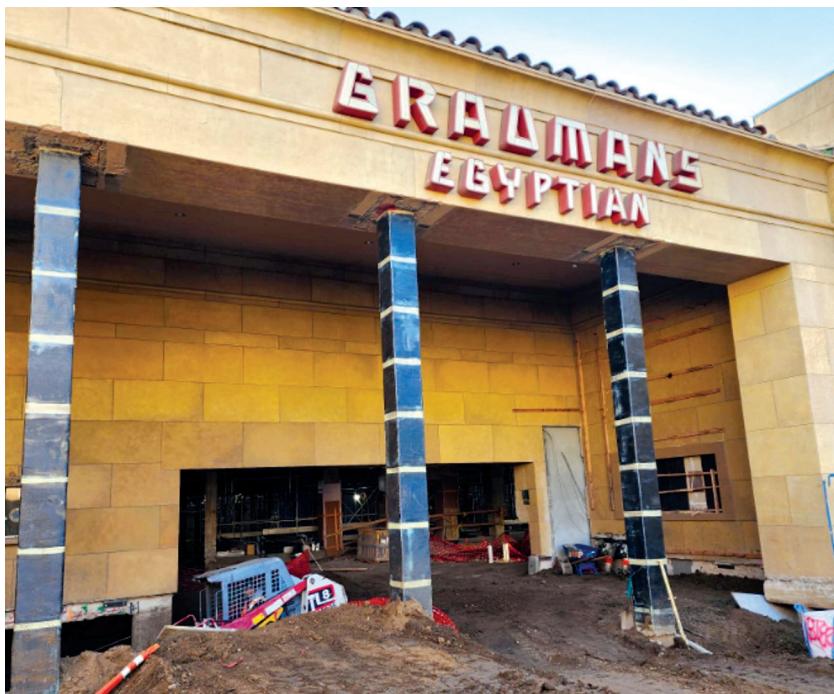
Fig. 7. After the portico columns were strengthened, they were analyzed to verify the plastic rotational capacity was adequate for the end rotations due to the inelastic building drift.

The independent gravity columns of the Theatre that were not integrated into new concrete shear walls were analyzed as deformation controlled secondary members according to ASCE 41 for seismic drift compatibility. The analysis revealed that the independent columns had inadequate shear strength to develop the full expected plastic flexural capacity of the columns and were classified as shear-critical. To strengthen the columns to achieve a flexure-critical condition, the required FRP shear strengthening to develop the full expected plastic flexural capacity was specified on the structural drawings as equivalent grade 60 shear reinforcing along with the existing material strengths and the classification of the member action for deferred submittal design (Fig. 7).

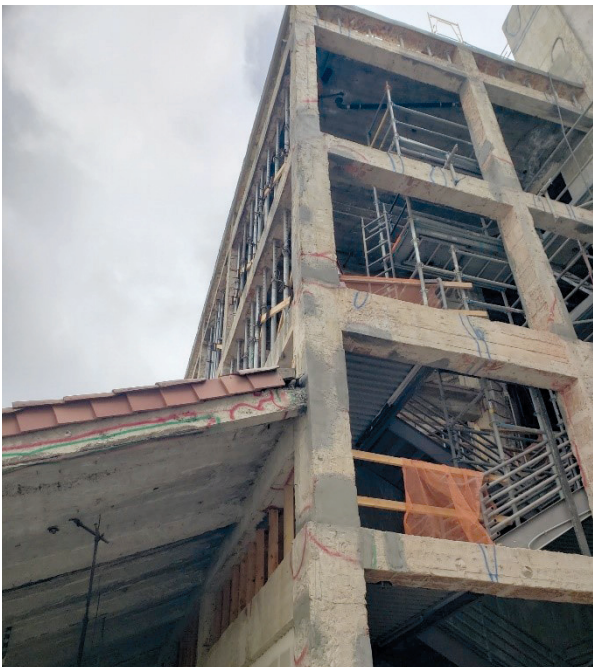
Fig. 8. Concrete frame repair at southwest portion consisted of shoring where required to remove and repair poorly placed concrete, mortar or epoxy injecting cracks, cleaning, and repairing corroded reinforcing, and placing repair mortar at spalls and to achieve proper clear cover on reinforcing bars.

During construction, despite the initial findings of the visual condition assessment during design, after the removal of all the exterior plaster finishes widespread poor-quality concrete and damage was found. Poor quality concrete consisted of inadequate consolidation, rock pockets, honeycombing, and inadequate reinforcement clear cover. Damaged concrete consisted of cracking, reinforcement corrosion, spalling, and delamination. The cracked concrete is likely partially due to damage during the Northridge earthquake and other regional earthquakes. A repair program was enacted to rectify these structural issues encountered since the full design strength of many of the original elements was necessary for the retrofit (Fig. 8).

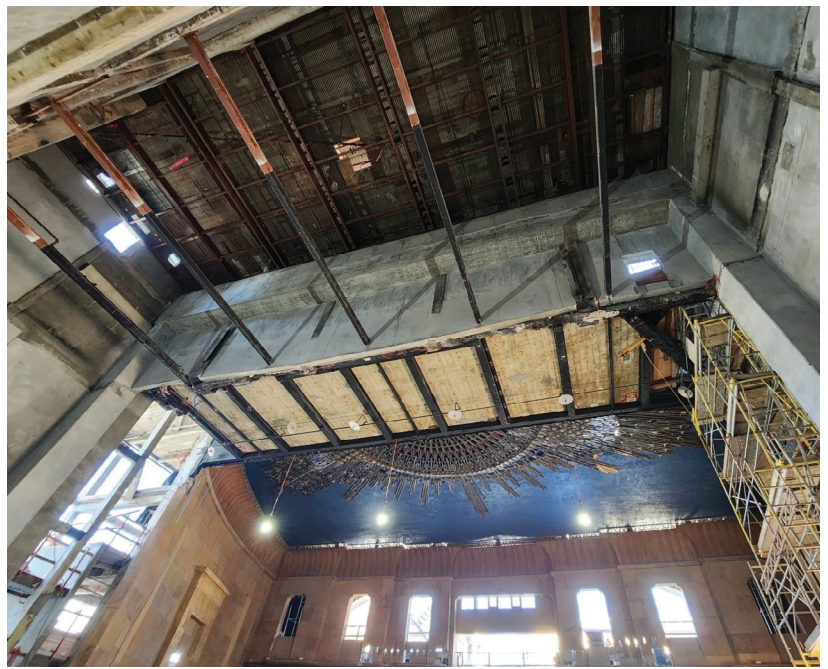
Fig. 9. To adequately transfer the new girder loads into the columns and to enlarge the column concrete area, an interior reinforced concrete column enlargement was designed to be epoxy doweled to the full height of the original column and to achieve direct bearing under the ends of the new proscenium girder.

During the early phases of the design, it was noted that the original proscenium columns on each side of the stage did not exist, and no documentation of this modification could be found. The original proscenium was designed with a narrow view of the screen, and it is likely that as movie projecting technology progressed, the desire for a wider screen resulted in the widening of the proscenium. As construction commenced and finishes were removed, it was alarmingly discovered that the columns had been demolished without adequately modifying the structure of the roof to increase the proscenium girder span from the original approximately 42 feet to the modified approximately 70 feet. Considering the tributary roof areas loading the proscenium girder line consisted of the high roof over the stage, the organ loft roof, and the organ loft floor slab, large shoring towers to support the deficient proscenium girder were installed. A new large concrete girder was designed to support the tributary roof and organ loft loads and span approximately 70 feet between the perimeter columns. The original perimeter columns that now supported the new girder were analyzed for the increased load and found to be deficient for confinement and concrete area. Since the columns could only be enlarged towards the interior to avoid changing the exterior historic features of the Theatre, the requirements for added confinement were designed as additional FRP strengthening and the equivalent grade 60 confinement reinforcing was specified on the structural drawings for deferred submittal (Fig. 9).
